**National Pollutant Discharge Elimination System  
(NPDES)  
Inspection Report**

**P4 Production, LLC – Processing Facility  
(a subsidiary of the Monsanto Company)  
Soda Springs, Idaho**

**NPDES Permit # ID0001198**

**Inspection date: September 17, 2013  
Report completion date: November 20, 2013**

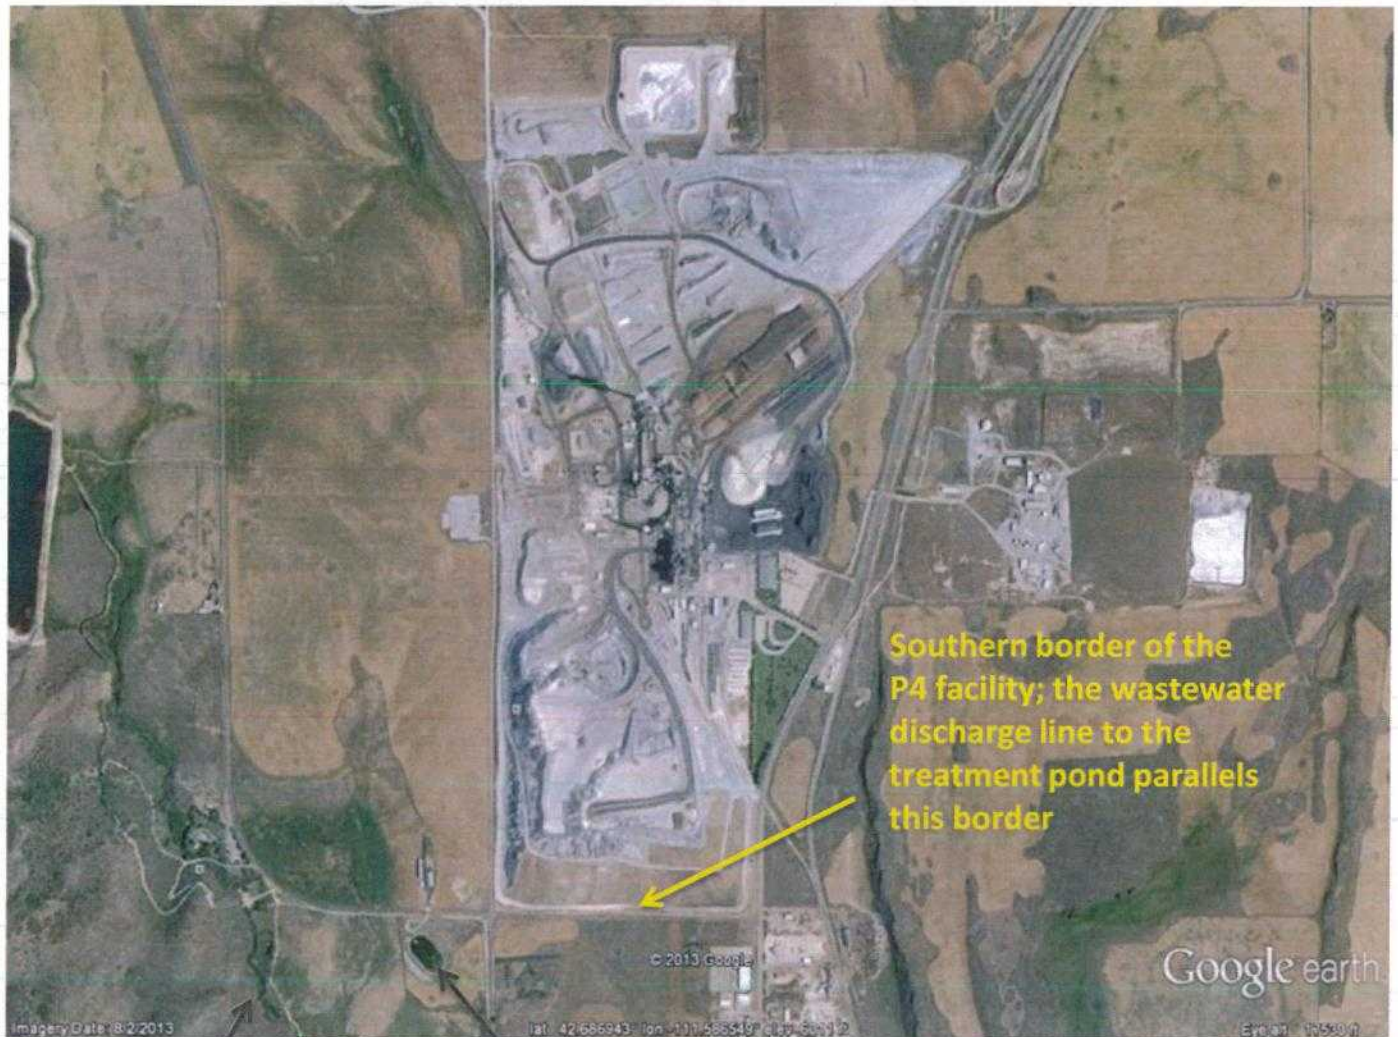
Discharge location  
to Soda Creek

Wastewater Treatment Pond

Photo No. 2 – from Google Earth Pro (imagery date 08/12/2013)  
Overview of the entire P4 Production and wastewater management operations

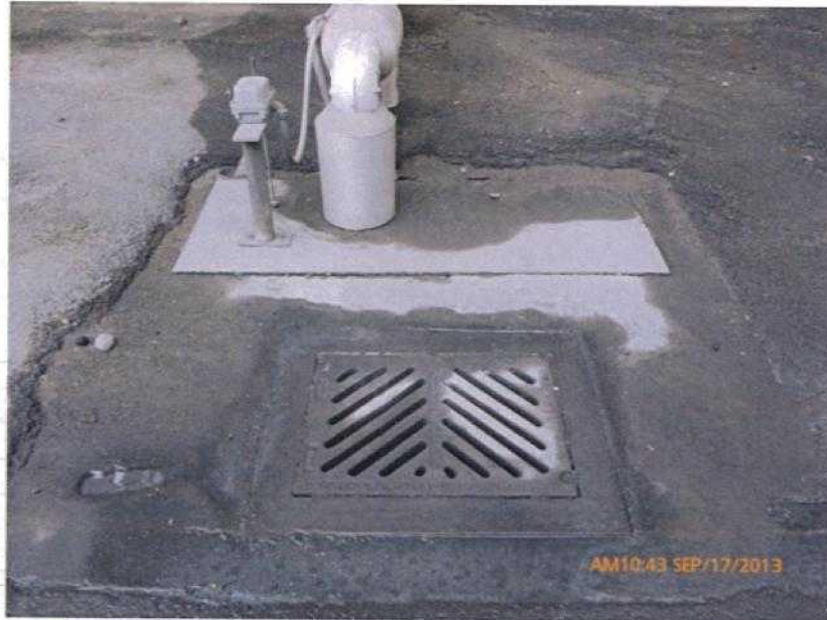
Photo No. 3 (P1000170)  
An example of the numerous storm drains located throughout the production facility

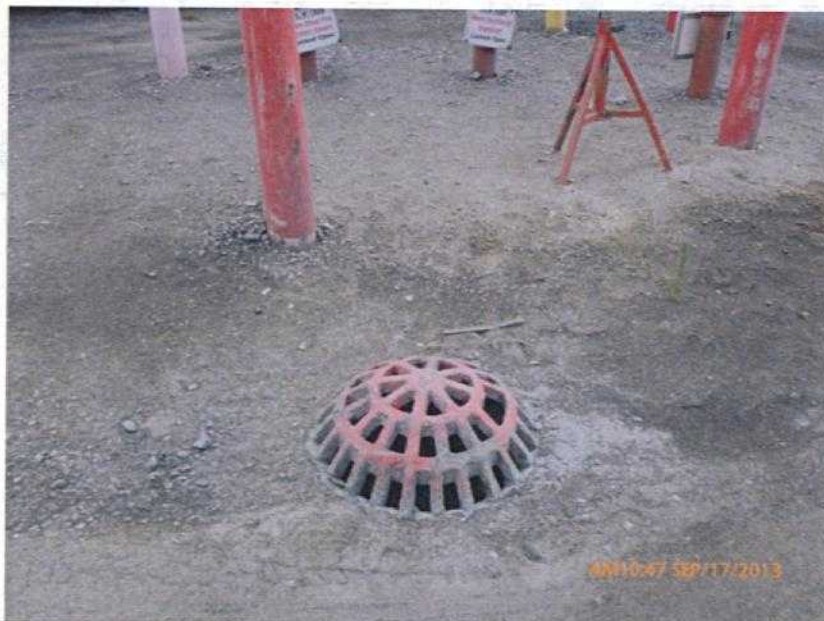
Photo No. 4 (P1000171)  
An example of the numerous storm drains located throughout the production facility

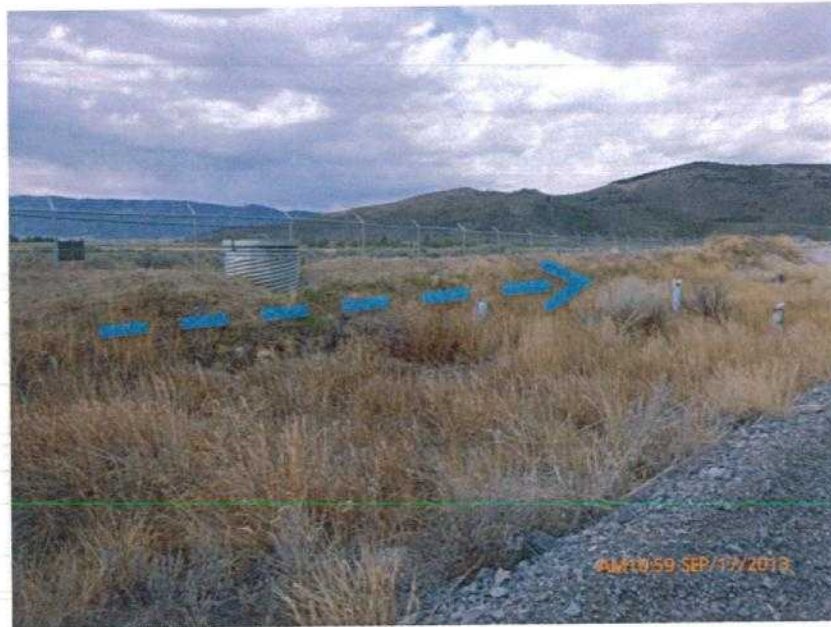
Photo No. 5 (P1000173)

A large culvert, shallowly buried along the southern border of the facility, conveys wastewater to the wastewater treatment pond. The vertical culvert is capped with an access manhole cover.

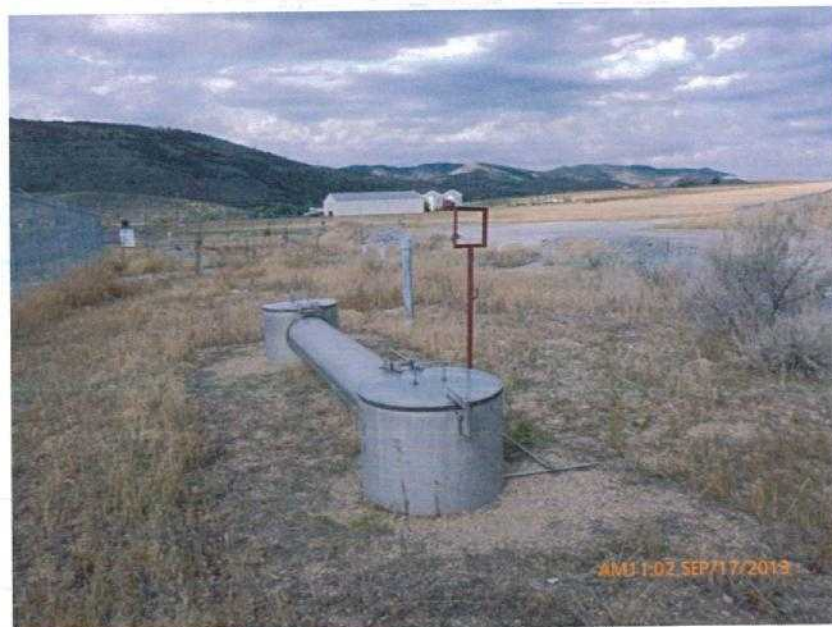
Photo No. 6 (P1000174)

Wastewater flows through this oil-water separator located in the SW corner of the facility property on its way to the treatment pond; monitoring wells (light blue) associated with on-site CERCLA activities are also evident in this photo.

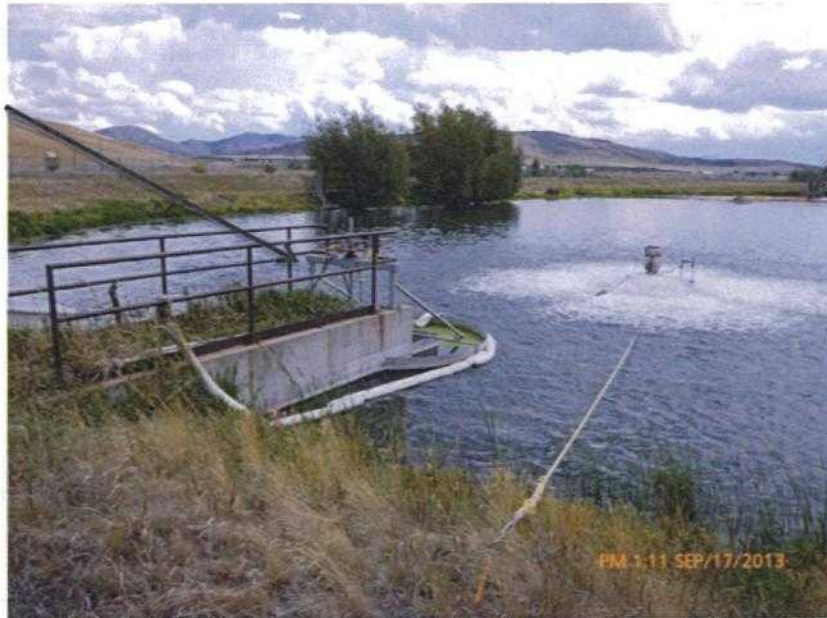
Photo No. 7 (P1000178)

Comingled wastewater from the three sources noted above is piped to a wastewater treatment pond (see Photos 3, 7, and 8) prior to discharge to Soda Creek. The pond is located approximately 1365' from the fenced southwest corner of the active portion of the facility. The capacity of the pond is approximately 335,000 cubic feet/2.5 M gallons. The treatment taking place within the pond is primarily physical in nature; some settling of solids occurs along with aeration and cooling.

Outlet from  
pond at  
NW corner

Inlet to  
pond at  
SE corner

The wastewater treatment pond at P4 Production, LLC  
with aerator operating within the pond

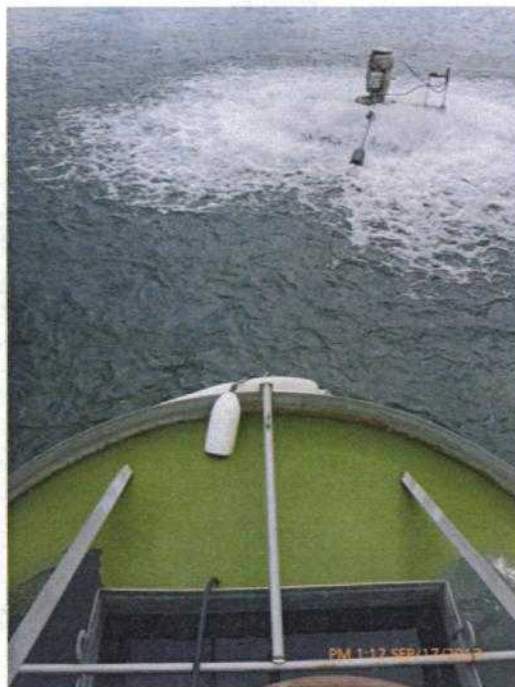
Photo No. 8 (P1000179)

Algae growth at outlet from the wastewater treatment pond

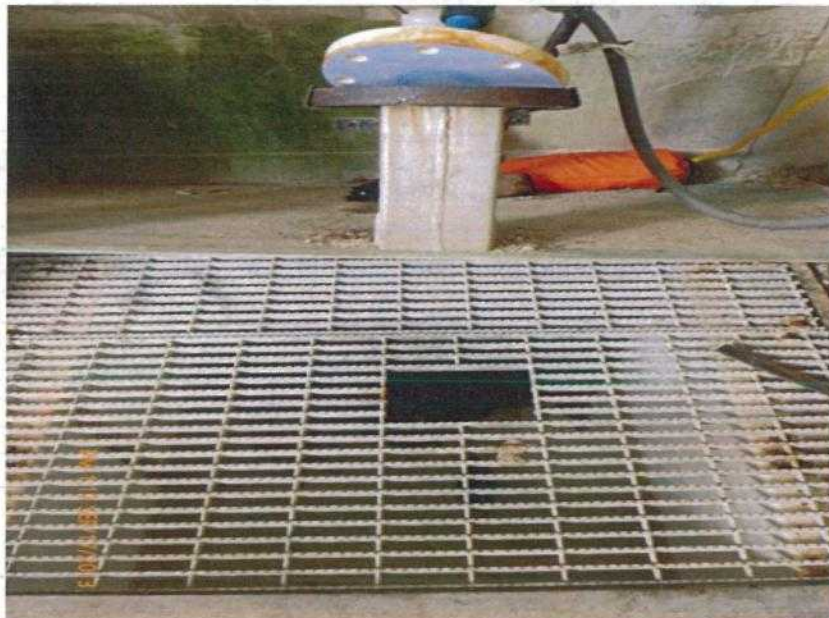
Photo No. 10 (P1000182)

A grate covers the Parshall flume used for measuring flow from the wastewater treatment pond to the discharge location at Soda Creek. The ultrasonic transducer appears at the top of the photo. A vertical water depth indicator is also mounted on the inside wall of the flume.

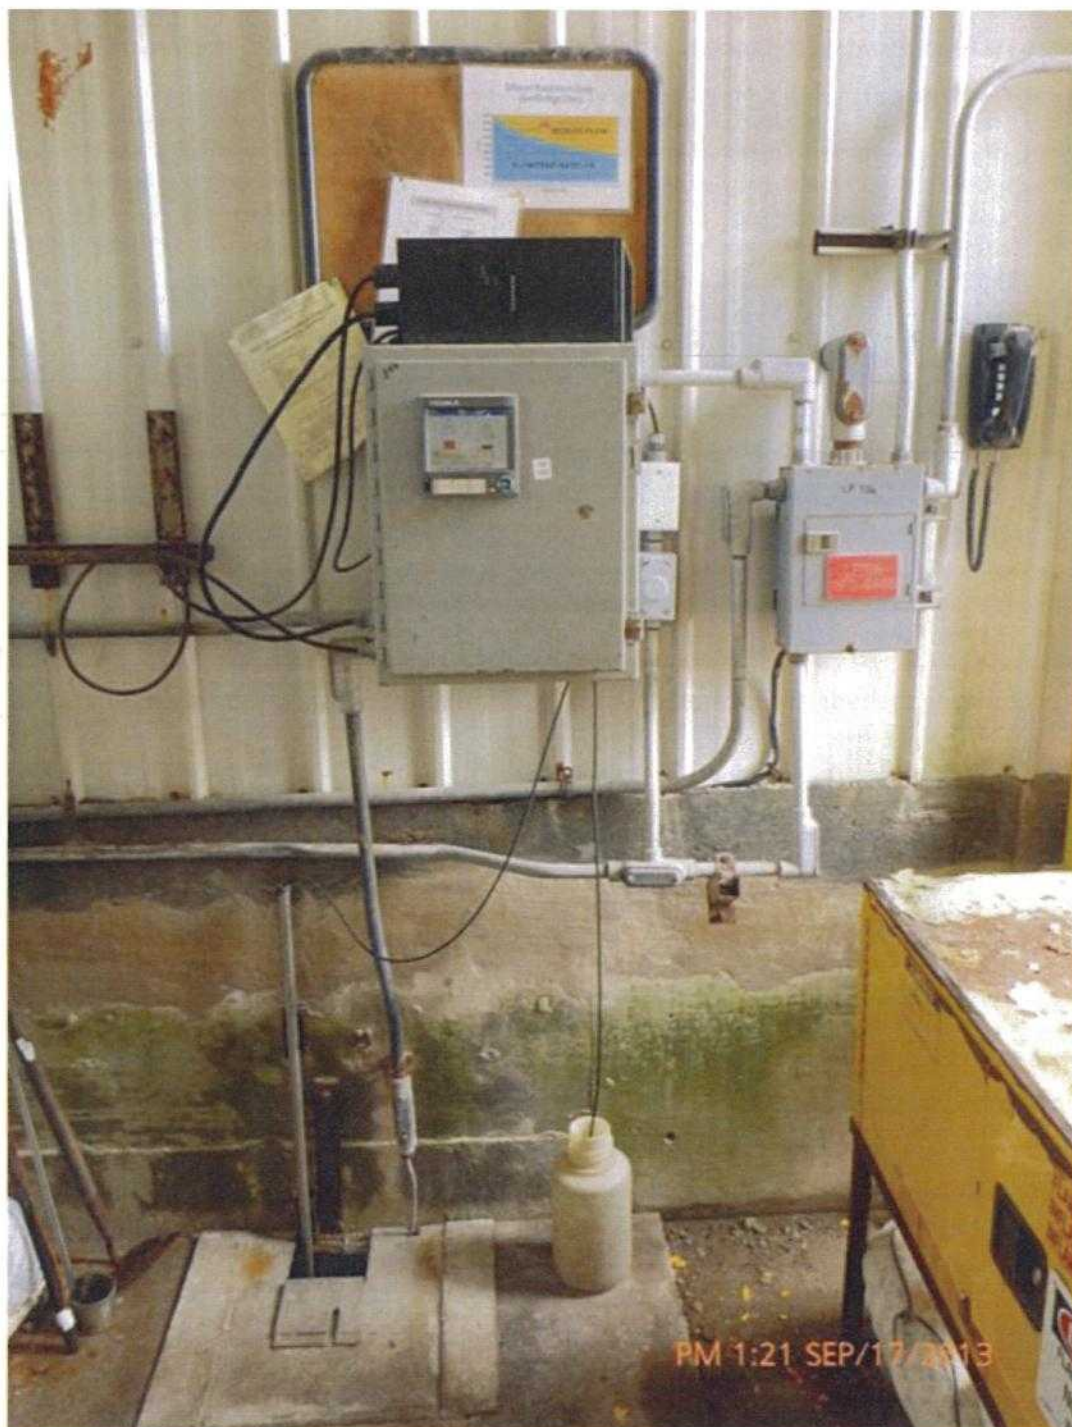
Photo No. 11 (P1000186)  
Data recorder for wastewater flow rate and temperature

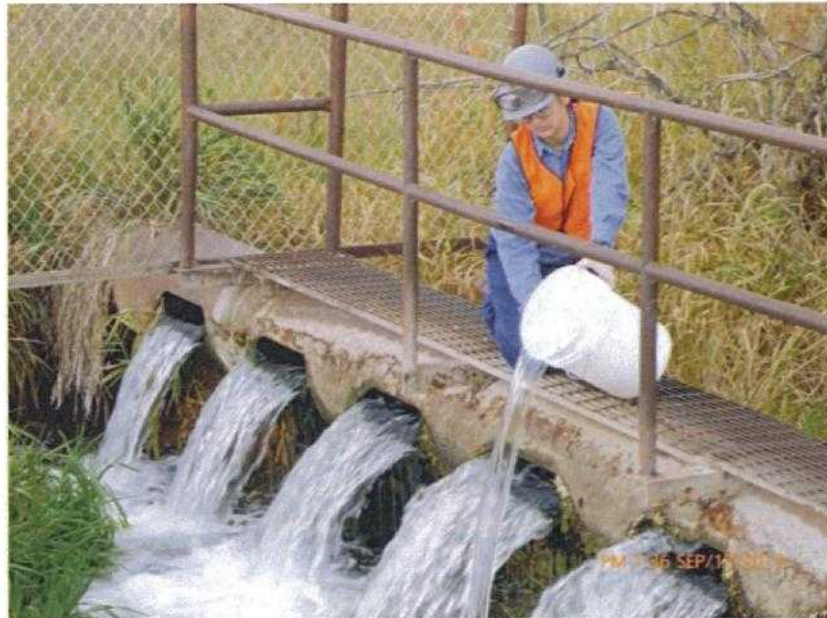
Photo No. 16 (P1000190)

P4 Production environmental engineer Molly Prickett triple-rinses the new HDPE bucket that was used to collect a single grab sample of the P4 discharge to Soda Creek.

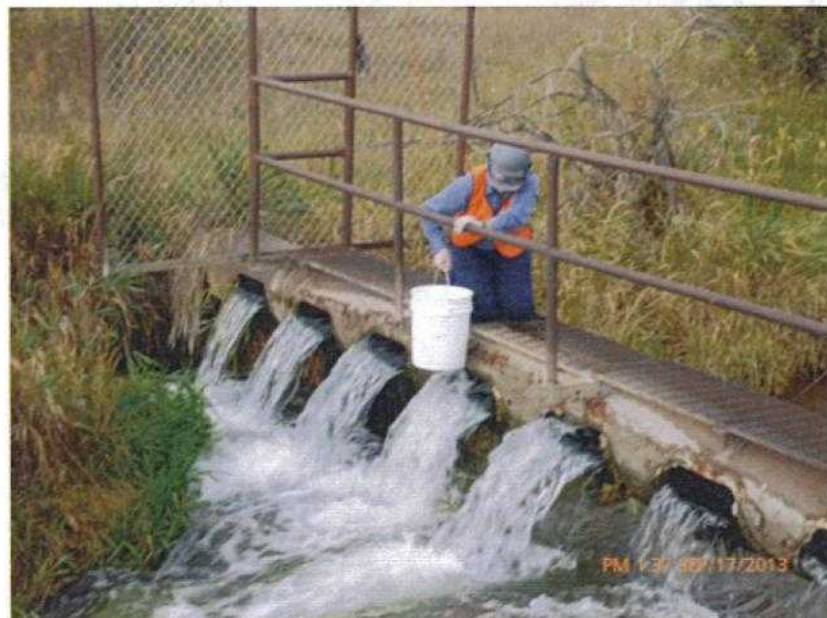
Photo No. 17 (P1000191)

P4 Production environmental engineer Molly Prickett collects a single grab sample of the P4 discharge to Soda Creek.

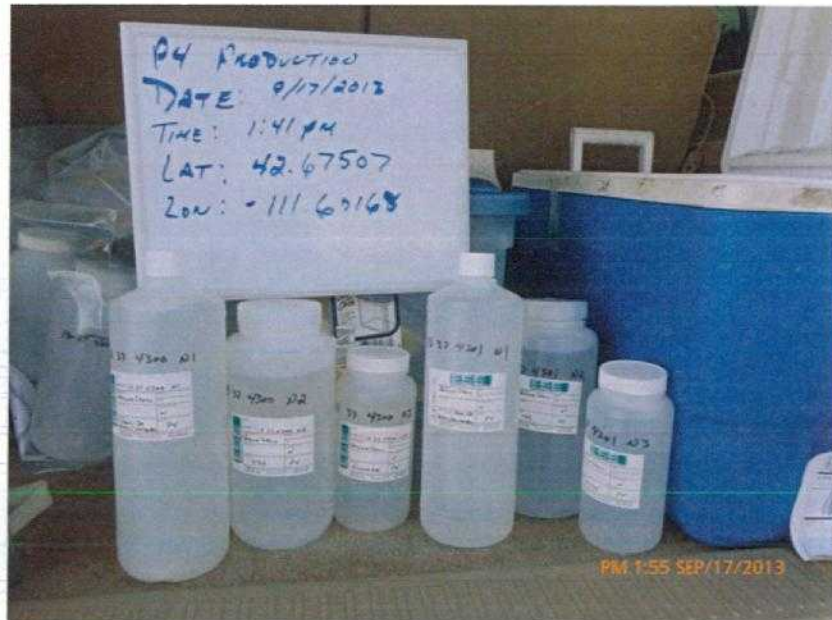
Photo No. 18 (P1000193)

Two sets of samples were collected from the single grab sample (original and a duplicate) collected at the discharge location.

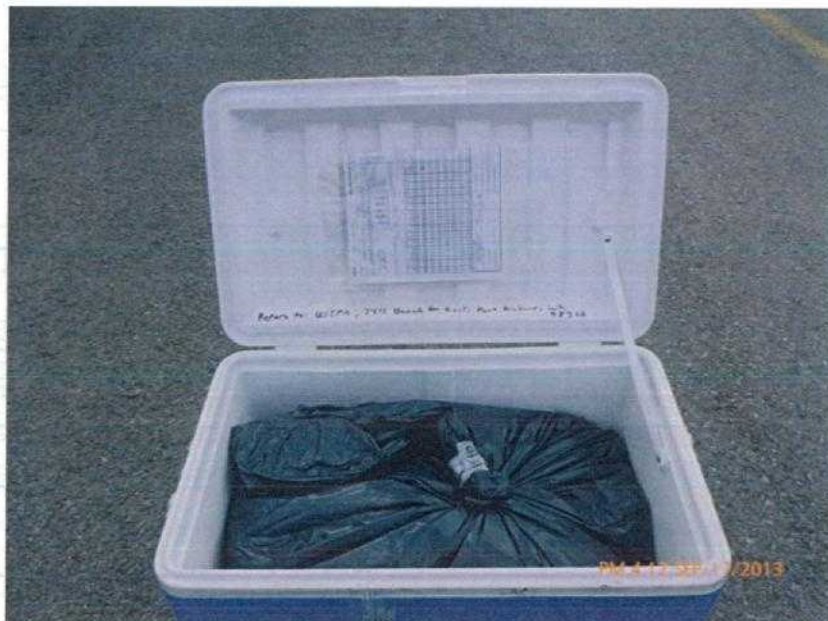
Photo No. 19 (P1000196)

Samples were packaged with ice, sealed with evidence tape, and placed in a cooler for shipment to the MEL lab; the Chain of Custody form was placed in a plastic bag affixed to the inside of cooler lid.
